APOLLO 16 MISSION
ANOMALY REPORT NO. 9

LUNAR ROVING VEHICLE ELECTRICAL SYSTEM METER ANOMALIES

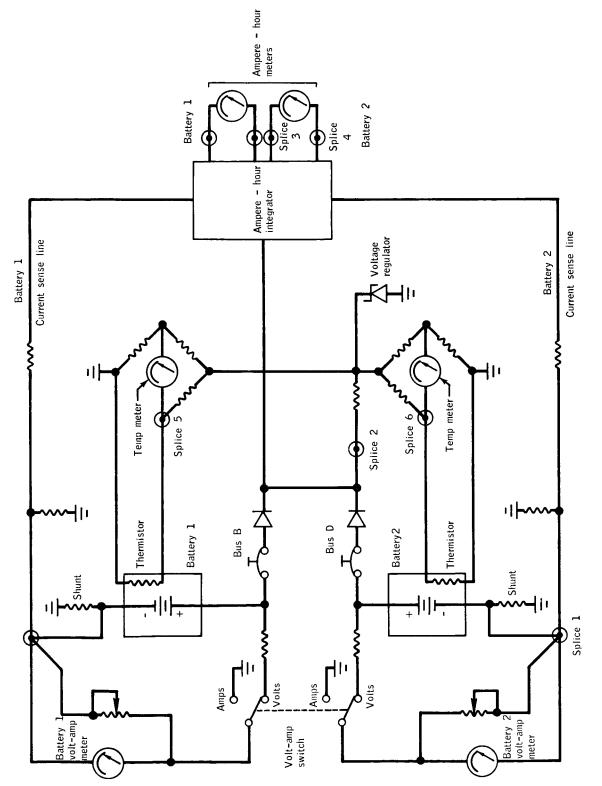
Figure 1.- Lunar roving vehicle electrical meters circuitry.

No single condition was found which would explain all anomalous meter indications. However, intermittent connections in some of the multiple wire crimp splices shown in figure 1 could explain the meter readings.

An intermittent connection in splice 1 could cause the battery 2 voltmeter to read off-scale low. Also, an intermittent connection in splice 3 or 4 would cause the battery 2 ampere-hour meter to read off-scale low. To cause both temperature meters to read off-scale low would require intermittents in either splice 2 or in both splices 5 and 6. An intermittent in splice 1 would cause the ampere-hour integrator 1 to indicate increasing rather than decreasing ampere-hours remaining, since the polarity on the current sense line would be reversed as shown in figure 2. Finally, an intermittent connection in splice 5 would cause the battery 1 temperature meter to indicate off-scale low.

Intermittent conditions must have existed in several of the multiple wire splices shown in figure 1.

No corrective action could be taken since the cause of the intermittents was not determined.

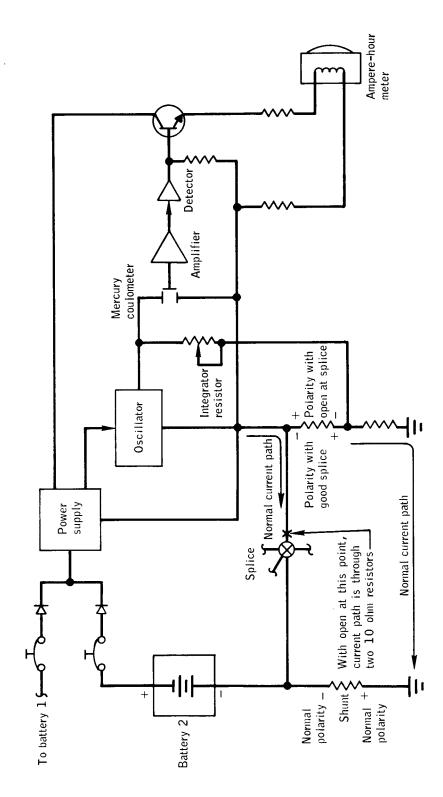
Figure 2.- Battery 2 amper-hour intergrator circuit.

The battery ampere-hour meter operates when either the bus B or the bus D circuit breaker is closed. The ampere-hour meter displays ampere-hours remaining in the batteries. This is accomplished as follows. A voltage, proportional to the battery current, is produced in the battery shunt (fig. 2). This voltage is applied through a resistor to an ampere-hour integrator. The resistor converts the shunt voltage into a current source.

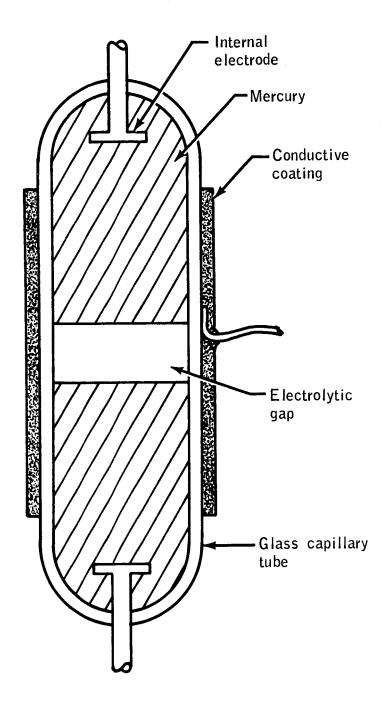
Figure 3.- Ampere - hour integrator.

The ampere-hour integrator (fig. 3) consists of a glass capillary tube which contains an electrode in each end and has an insulated external conductive coating. Between the two internal electrodes is a column of mercury with an electrolytic gap. When direct current flows between the internal electrodes, mercury is electroplated across the gap and the position of the gap moves. The position of the gap is then determined by the total coulomb charge which has been passed through the device.
